**REPORT OF
RAINFALL EVENT,
SEPTEMBER 22-25, 1983
NORTH AND WEST
PALM BEACH COUNTY**

**Water Resources Division
Resource Planning Department**

South Florida Water Management District

October 1983

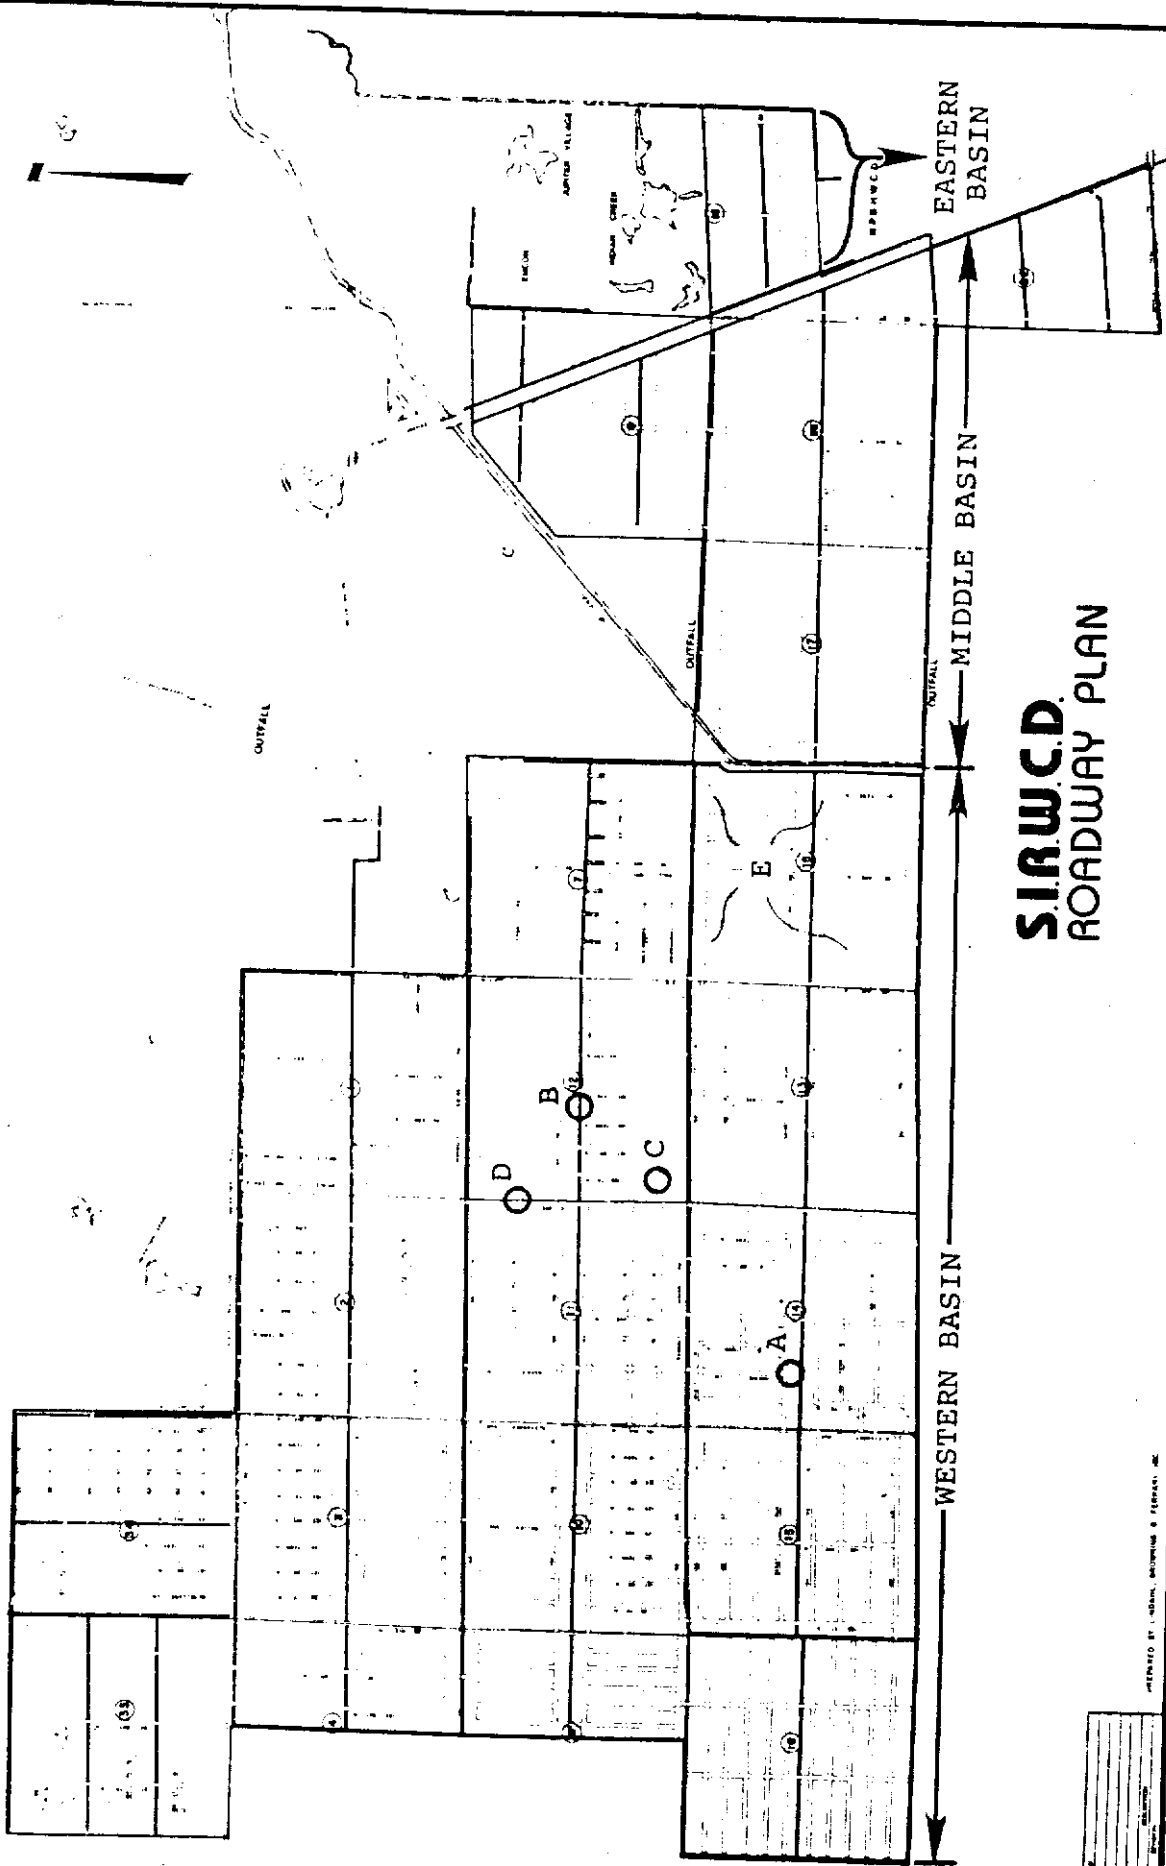
FIGURE 10

District staff inspected the area on Monday, September 26, 1983, (2nd day after the storm) and observed contract repair crews from the South Indian River Water Control District working on restoring road wash-outs and removing ditch "wash-ins". The western half of the western basin was generally dried out with only small pockets of water standing on property. The eastern half of the western basin still had road wash-outs and standing water. (See Figure 10.)

- A - ROAD WASHOUT
- B - ROAD WASHOUT
- C - LOT FLOODING
- D - LOT FLOODING
- E - AREA WITH 18" STANDING WATER
